EVALUATION OF DOW CHEMICAL PRODUCTION EXTRUDED TRUSS-WEB LANDING MAT

D. W. White, Jr.

March 1974

Conducted by U. S. Army Engineer Waterways Experiment Station
Soils and Pavements Laboratory
Vicksburg, Mississippi

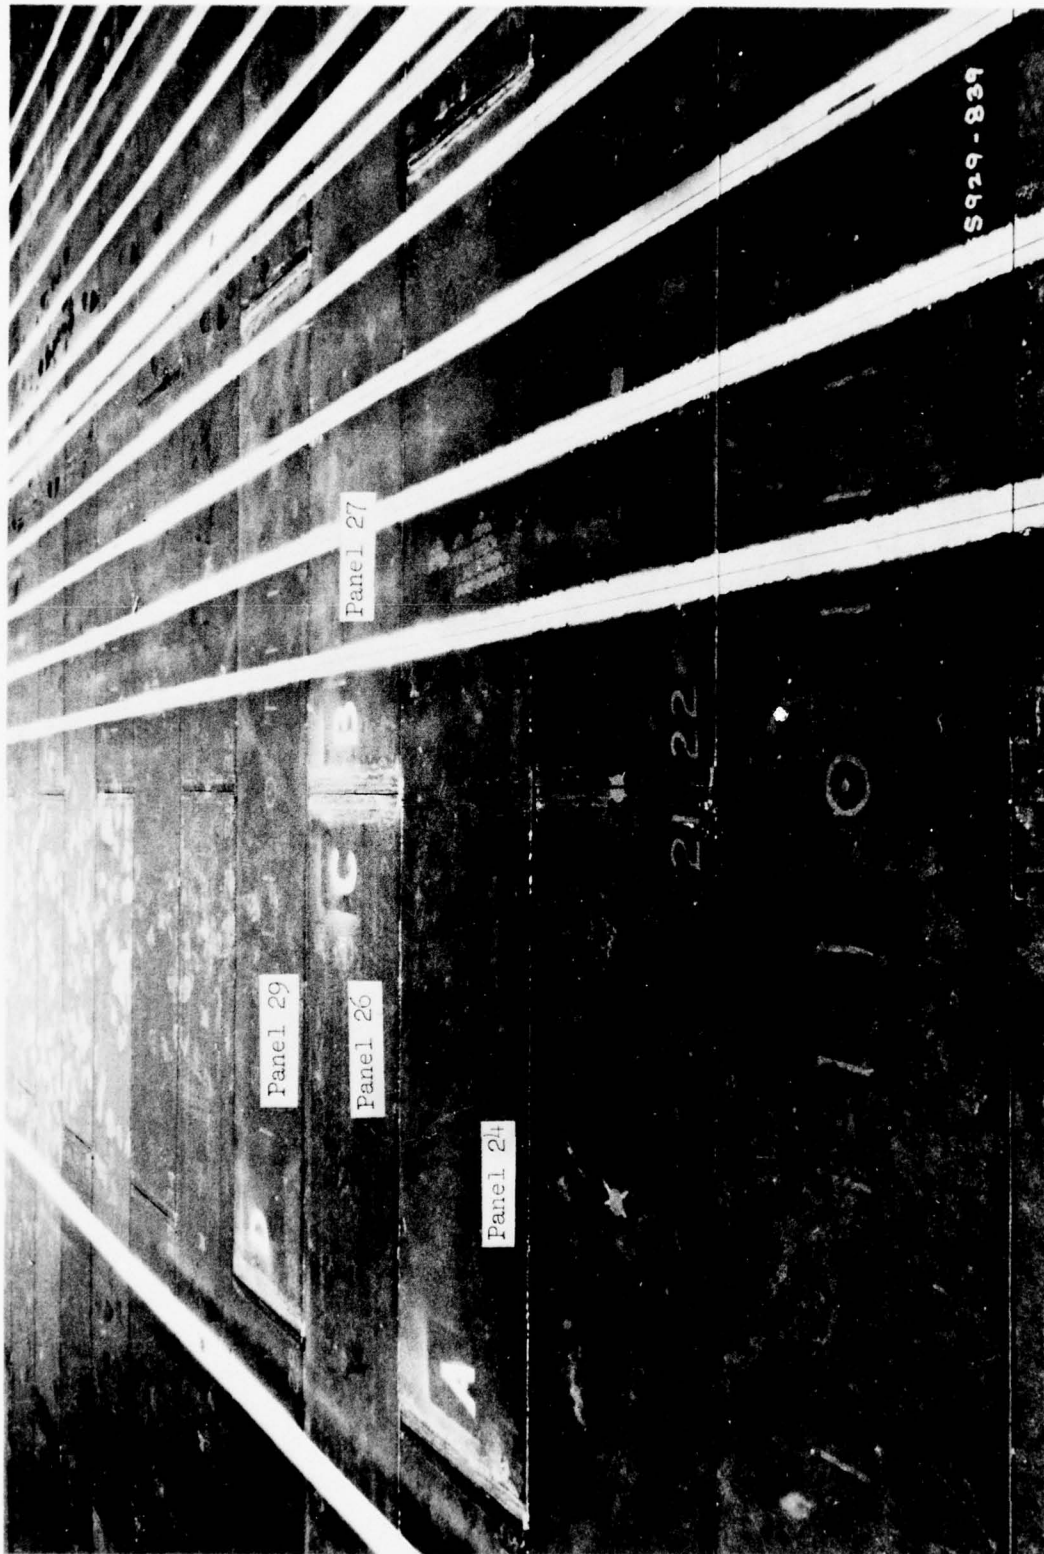
Panels APG inspected for weld cracks

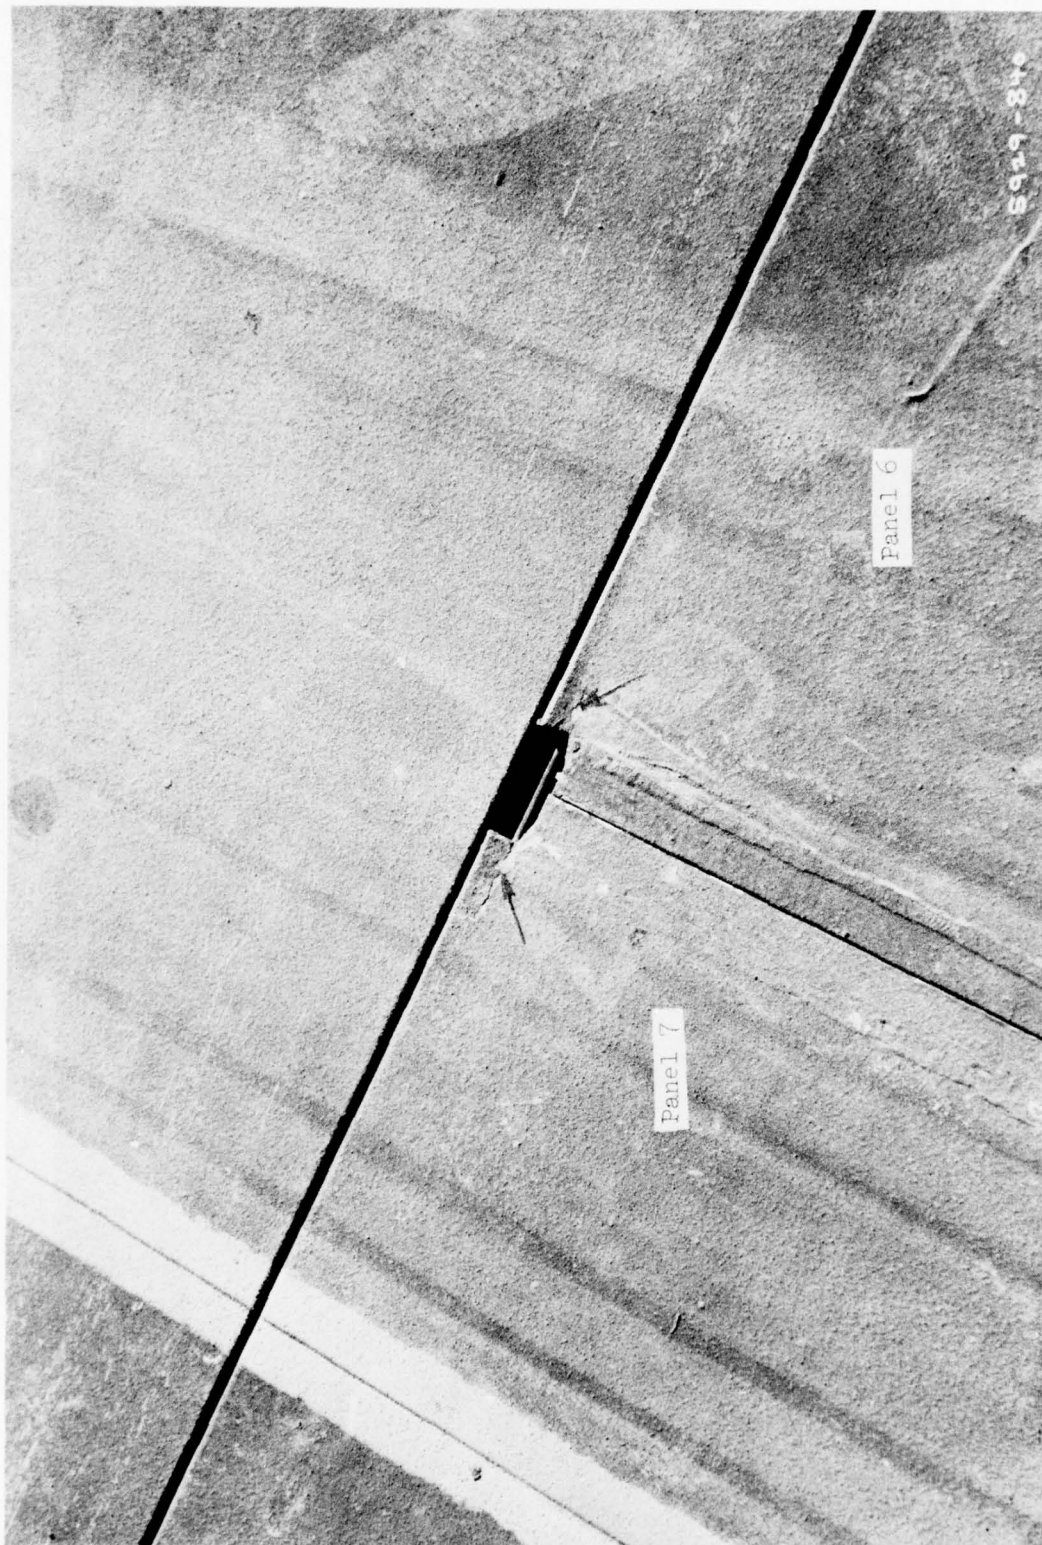
Curl on panels 6 and 7 (note antiskid flaking at corners)

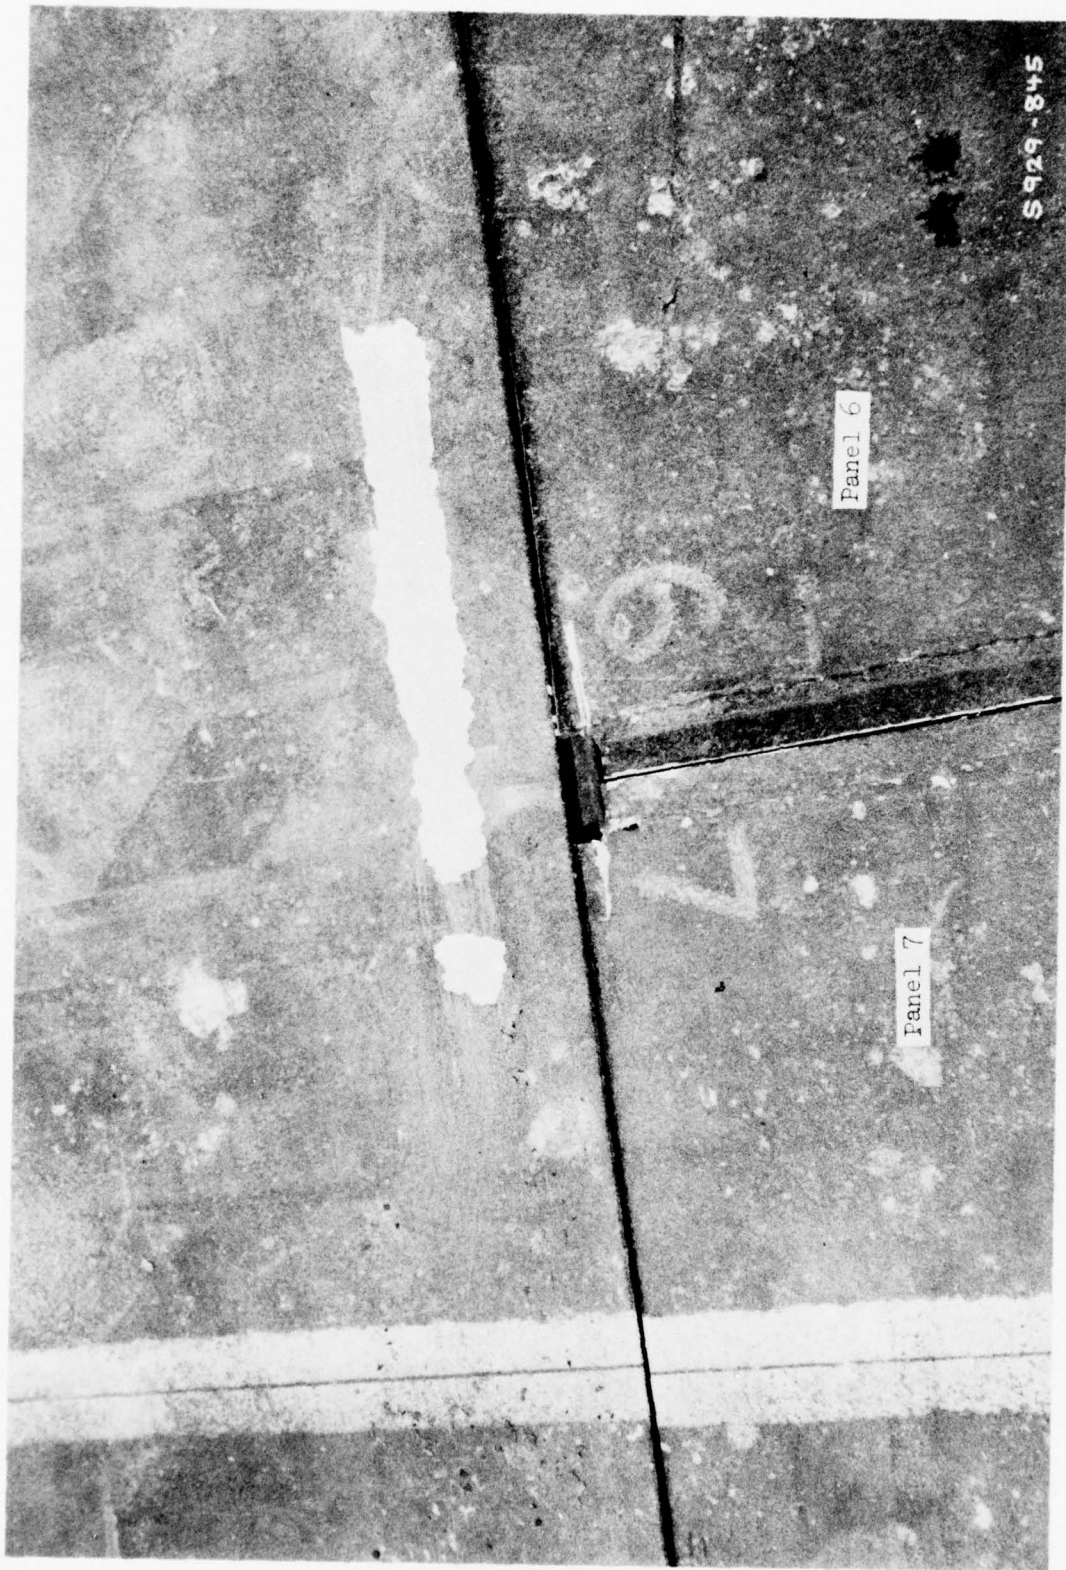
Panels 6 and 7 after 100 coverages

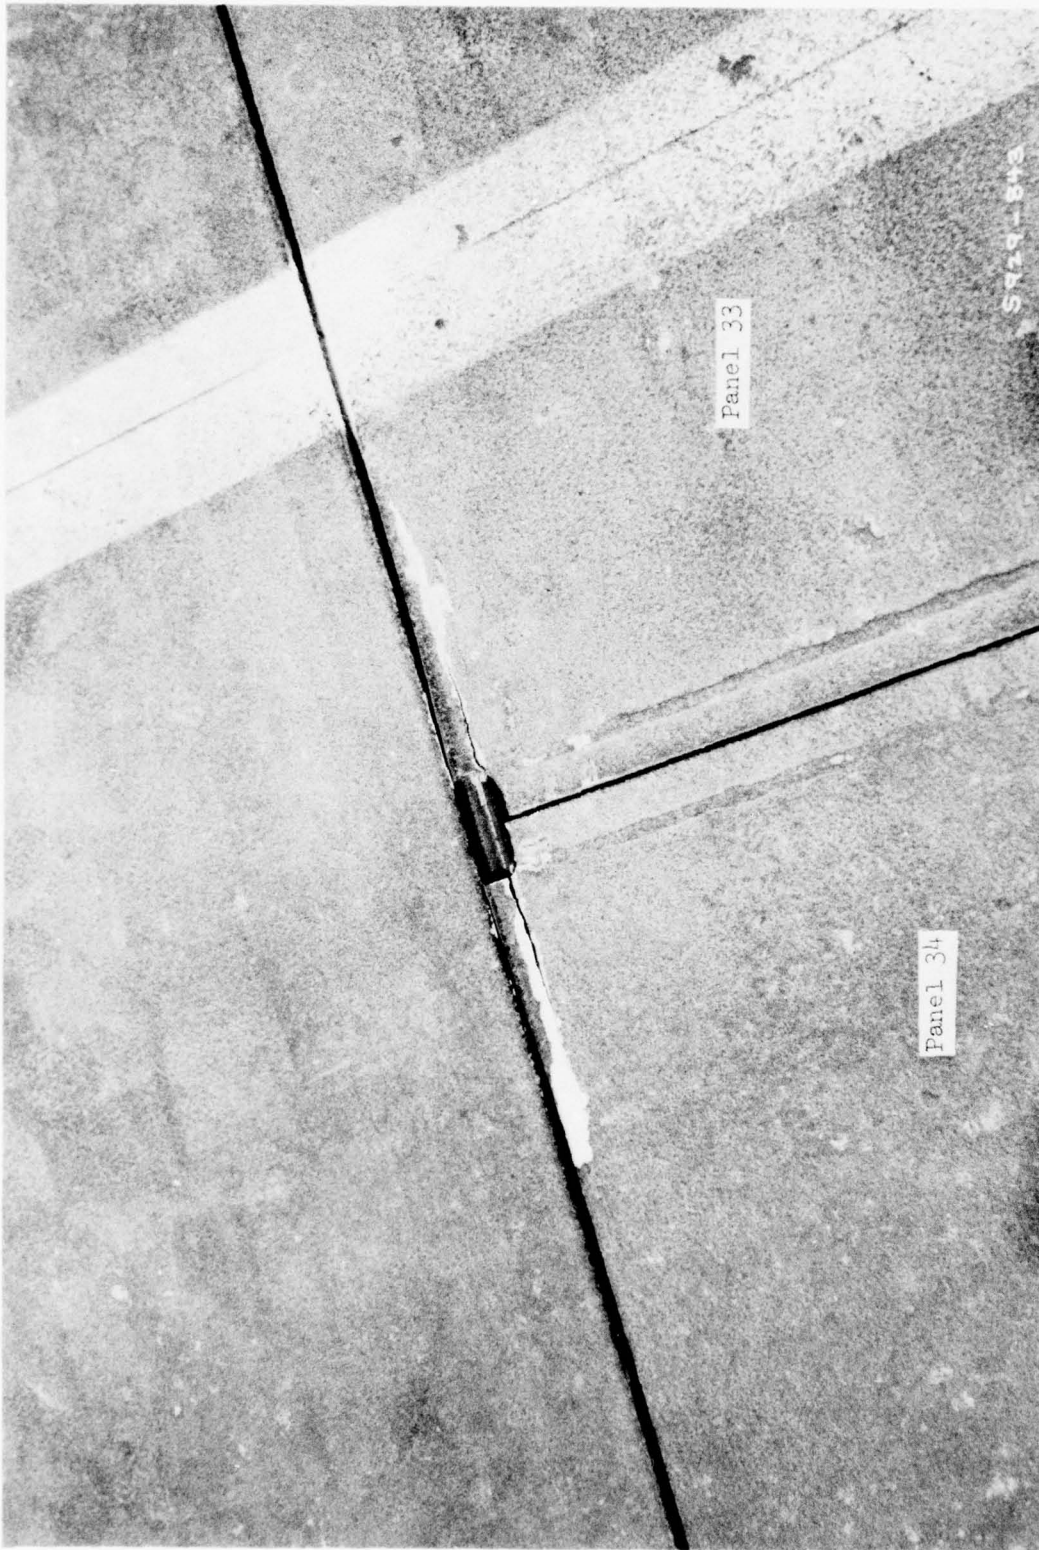
Panels 33 and 34 after 100 coverages

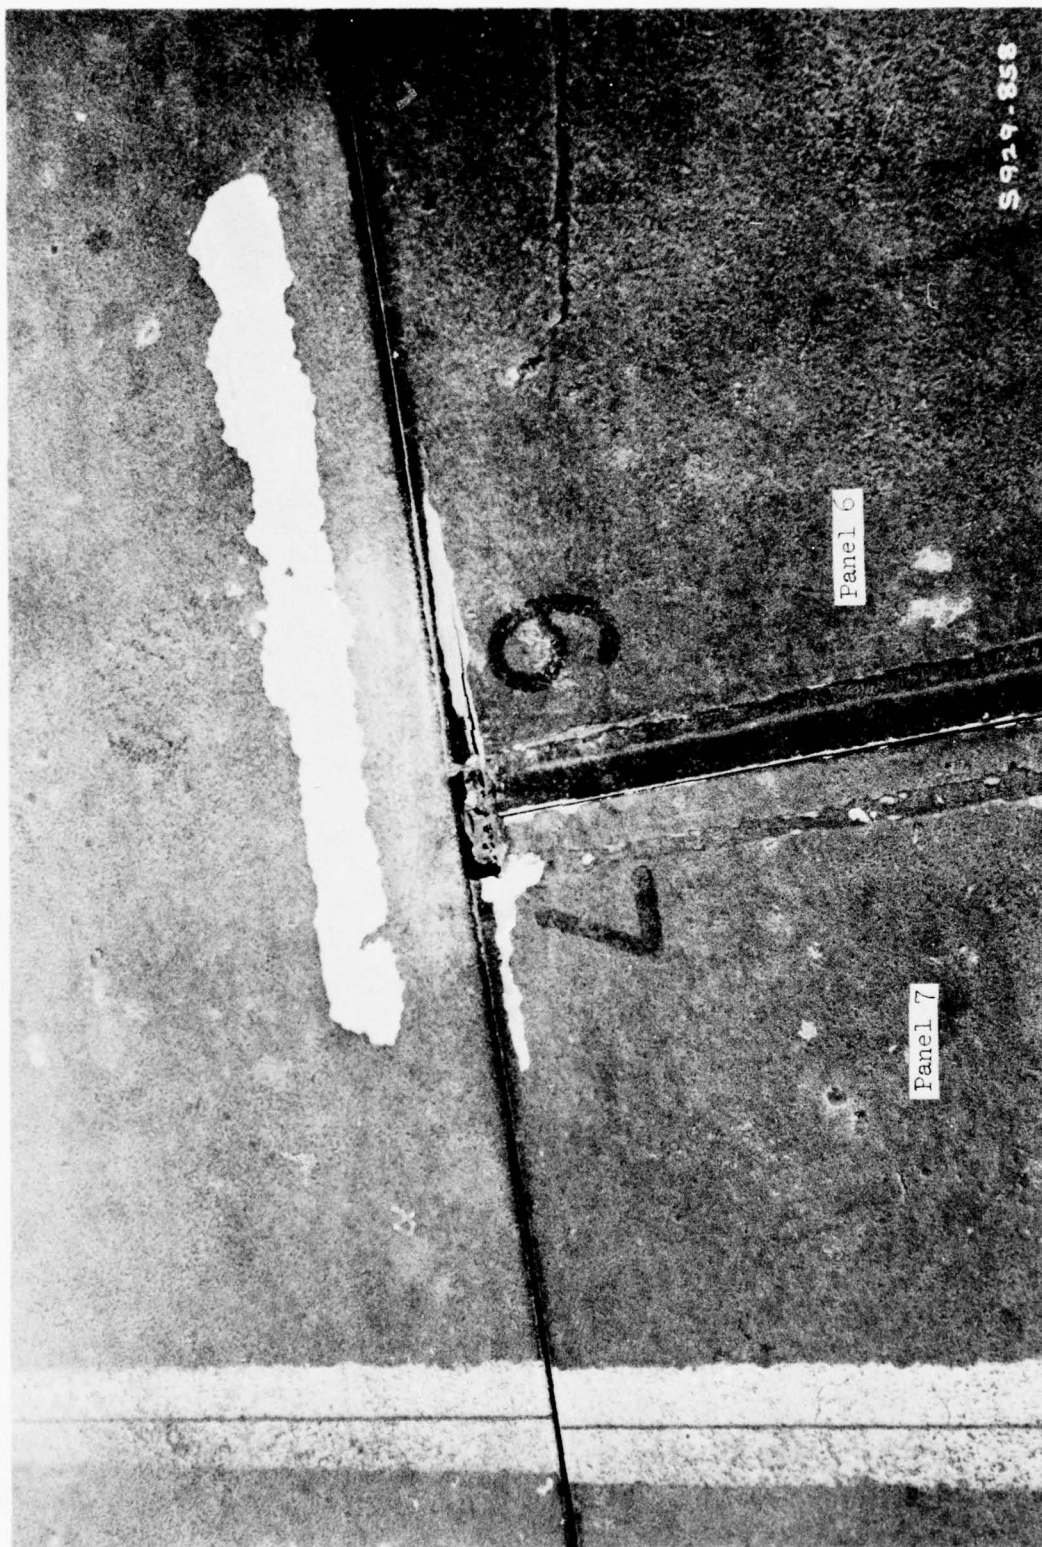
Panels 6 and 7 after 240 coverages

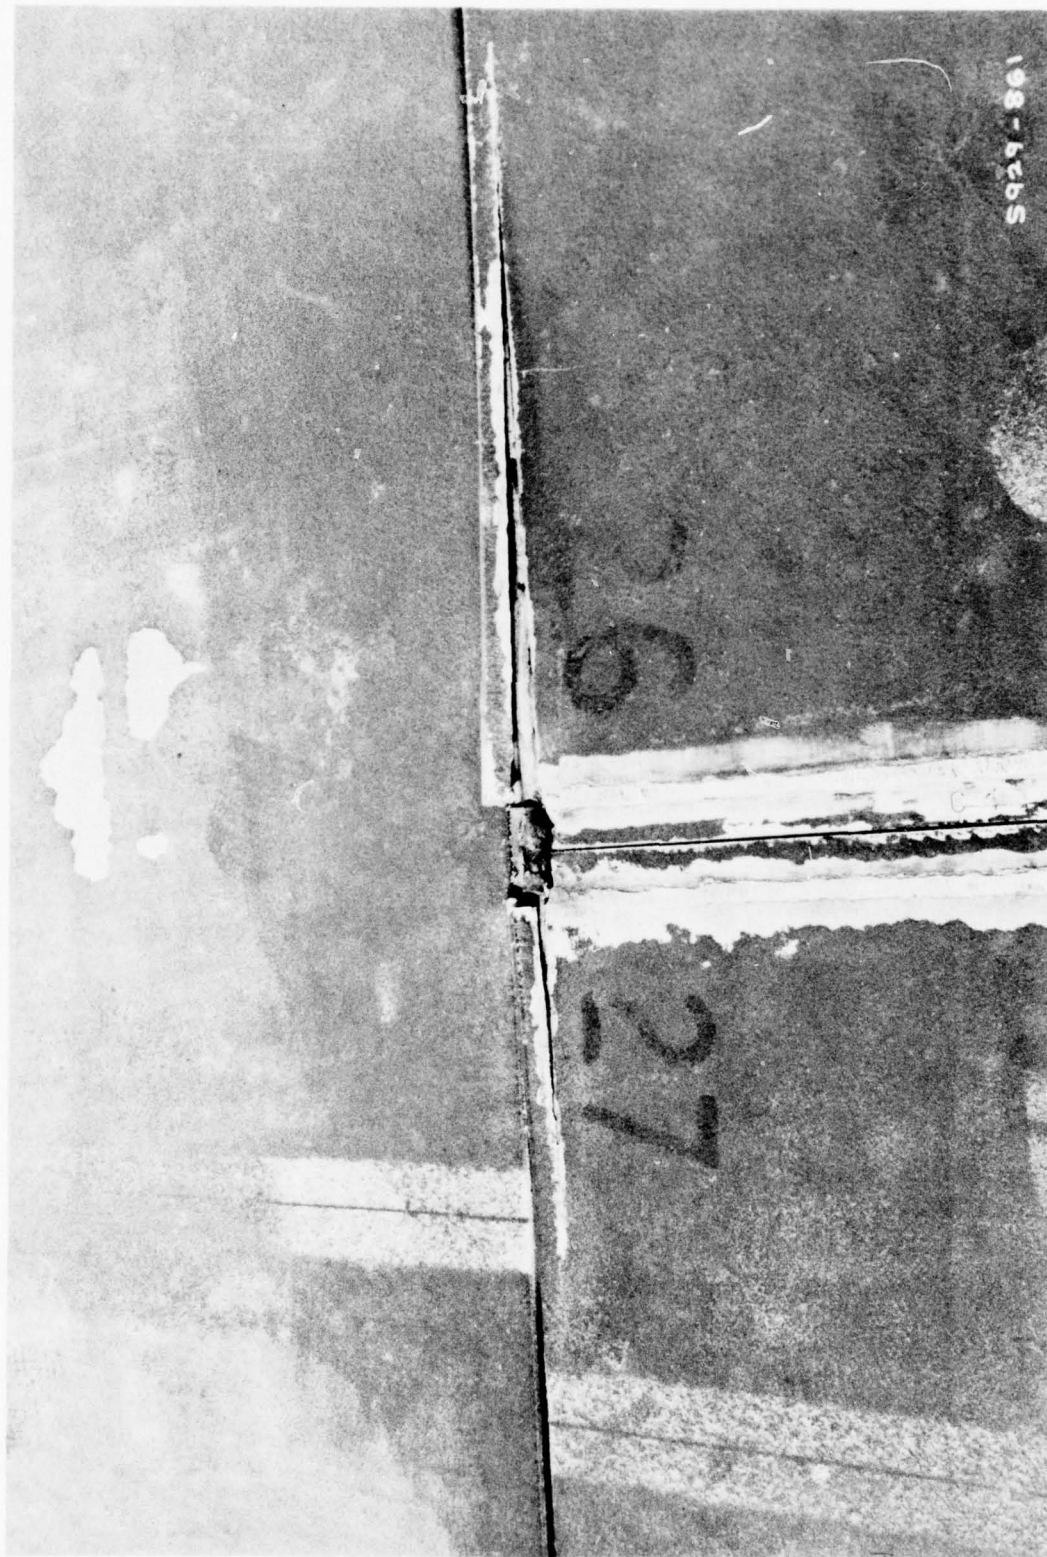
Panels 26 and 27 after 240 coverages

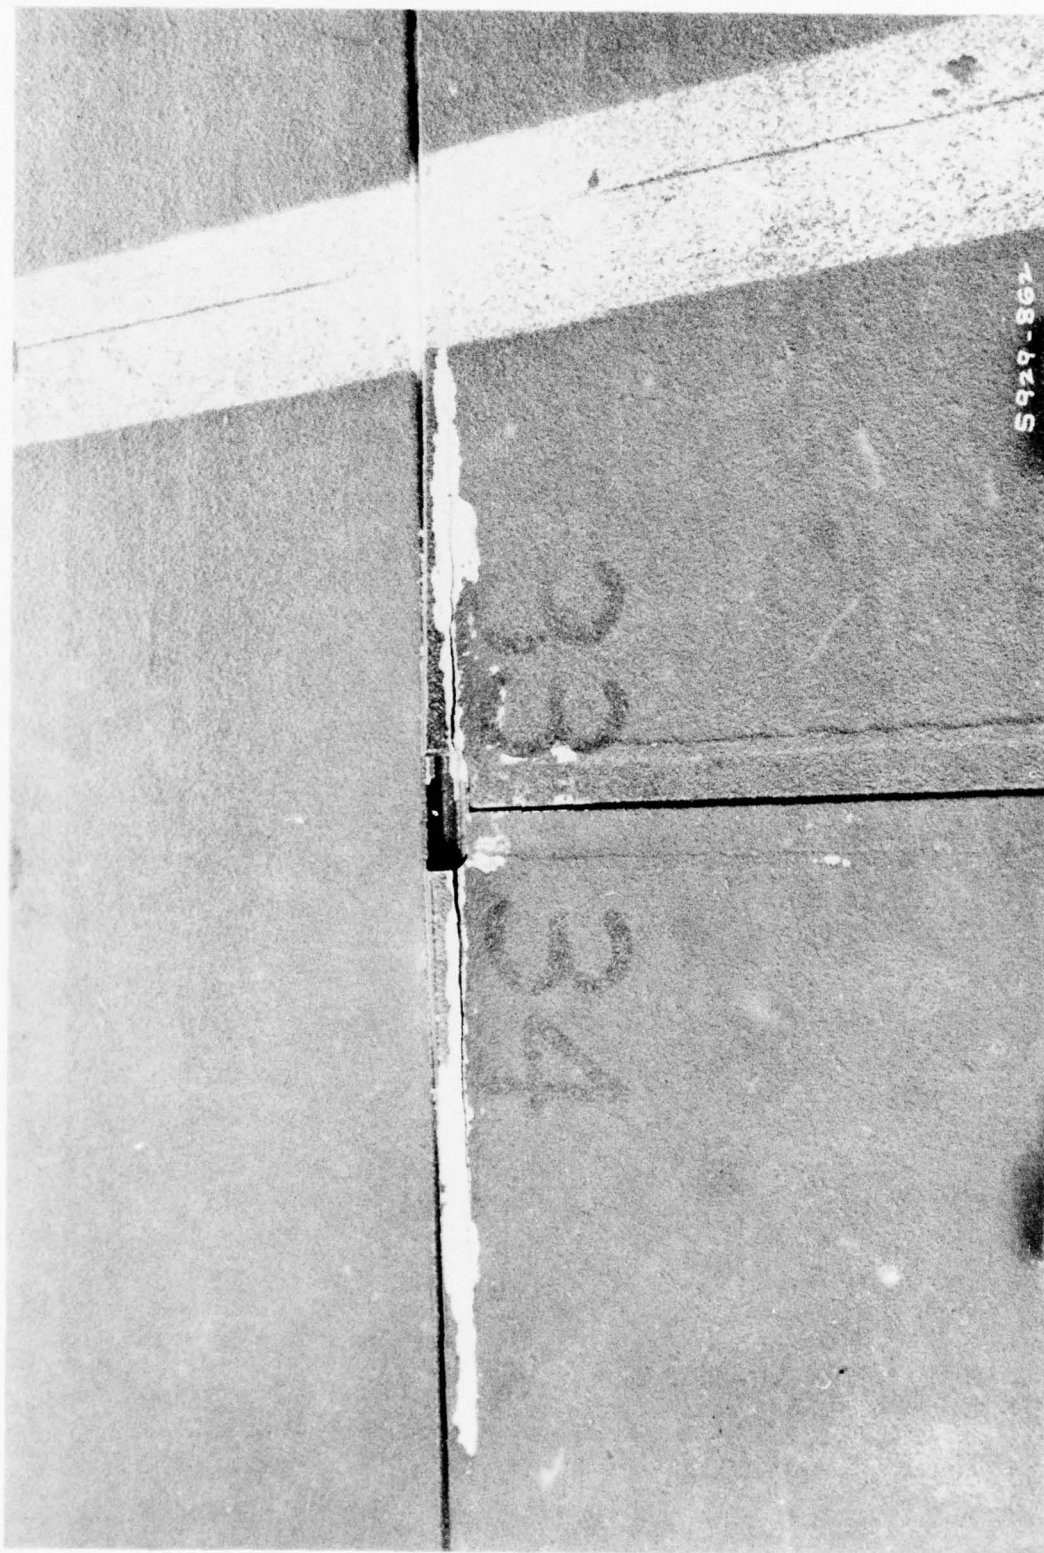
Panels 33 and 34 after 240 coverages

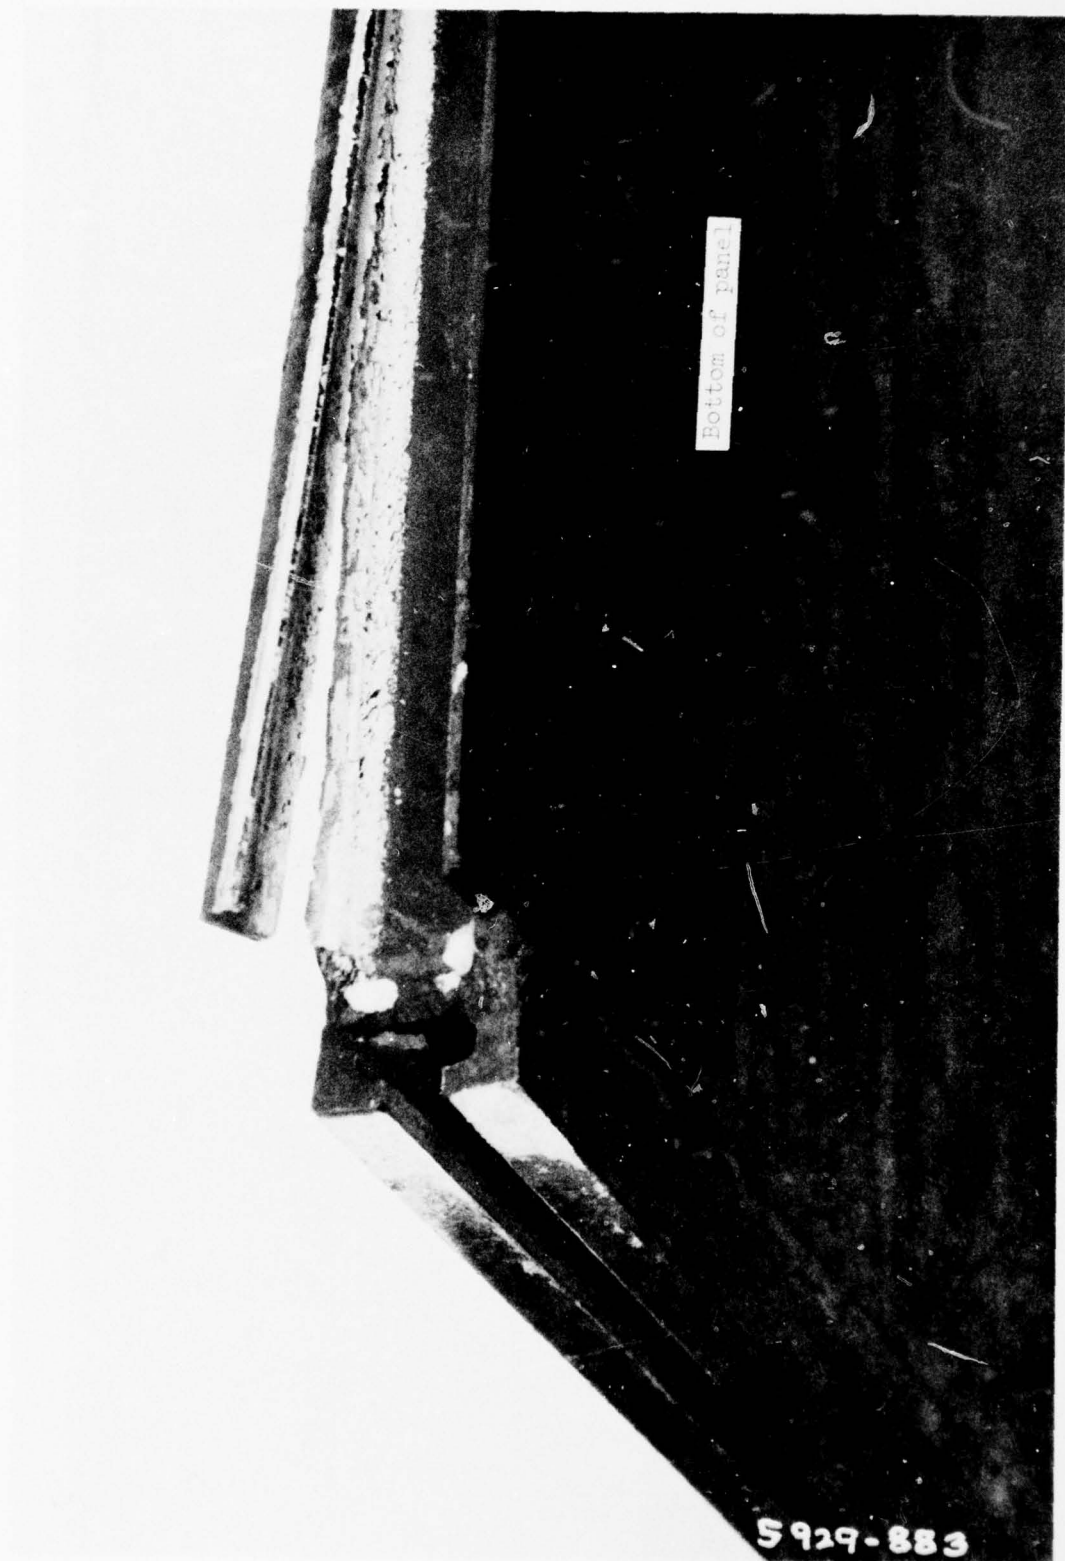
a. The mat sustained only 240 of the required 1000 coverages of the 50,000-lb SWL with a 250-psi tire-inflation pressure on a 4-CBR subgrade prior to failure of the mat due to splits along the female connectors at the panel corners.

Split in female connector after 240 coverages

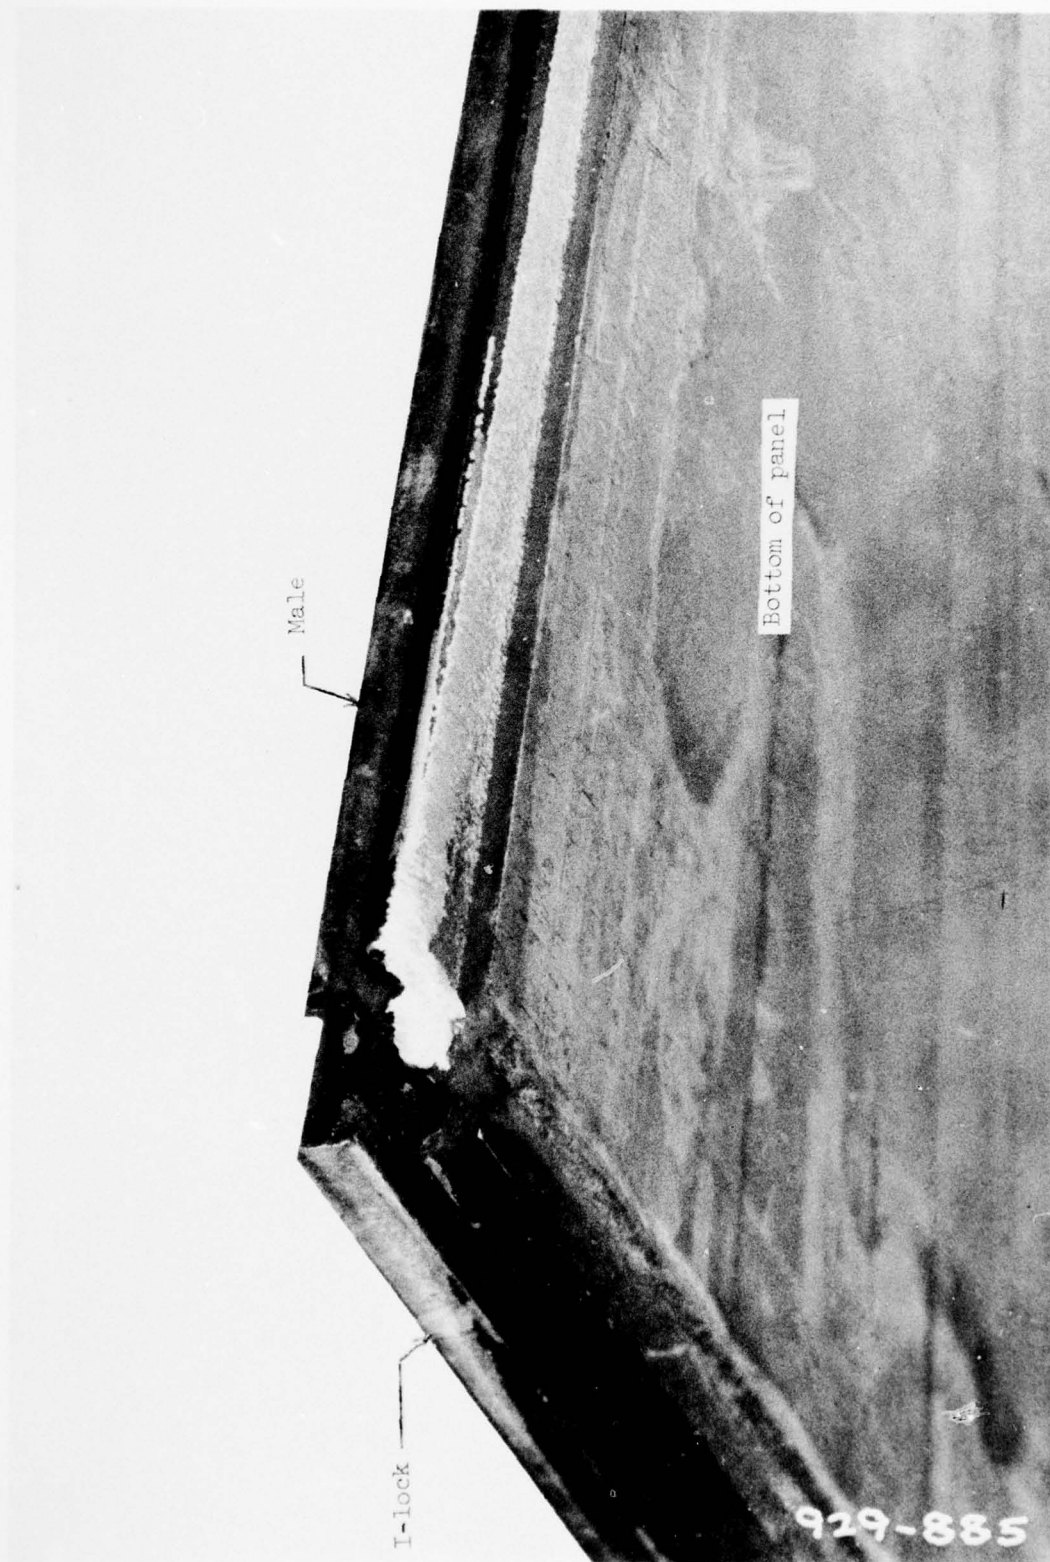
Wear and abrasion of male and I-lock connectors after 240 coverages

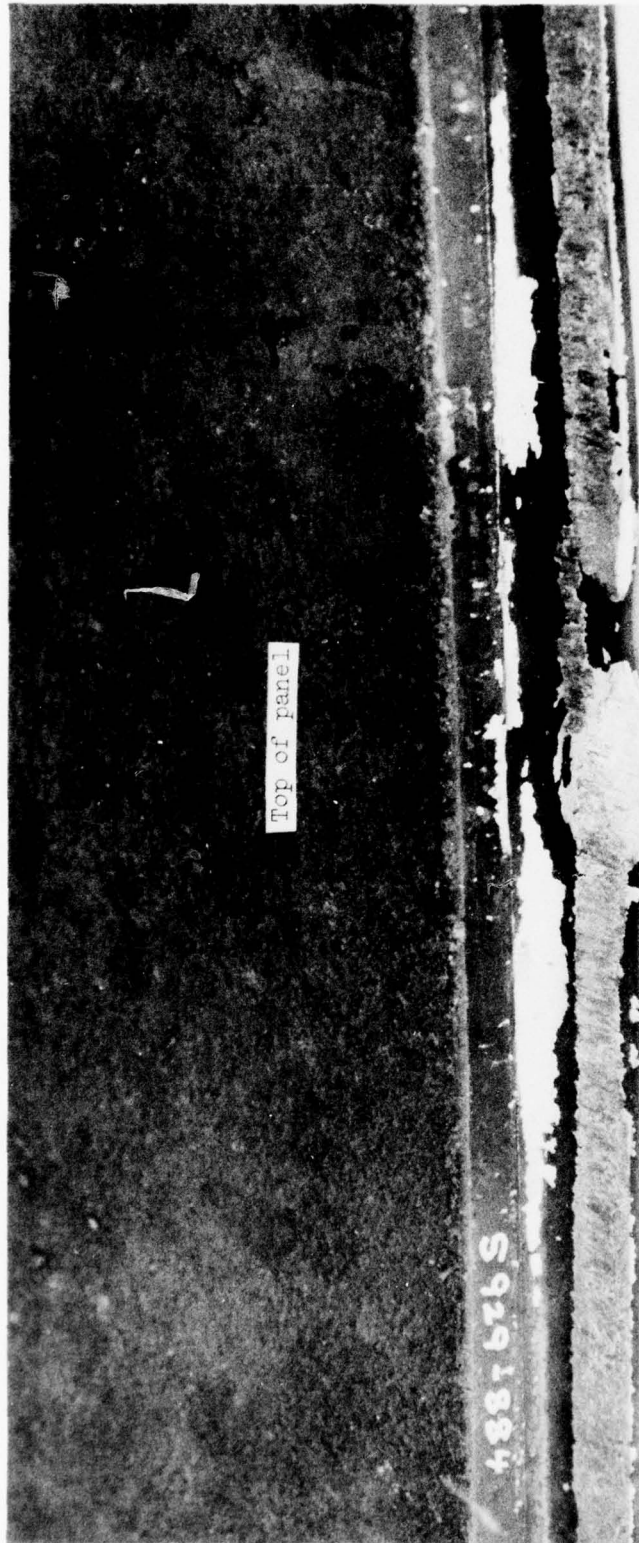
Wear and abrasion of female connector (at center of panel) after 240 coverages

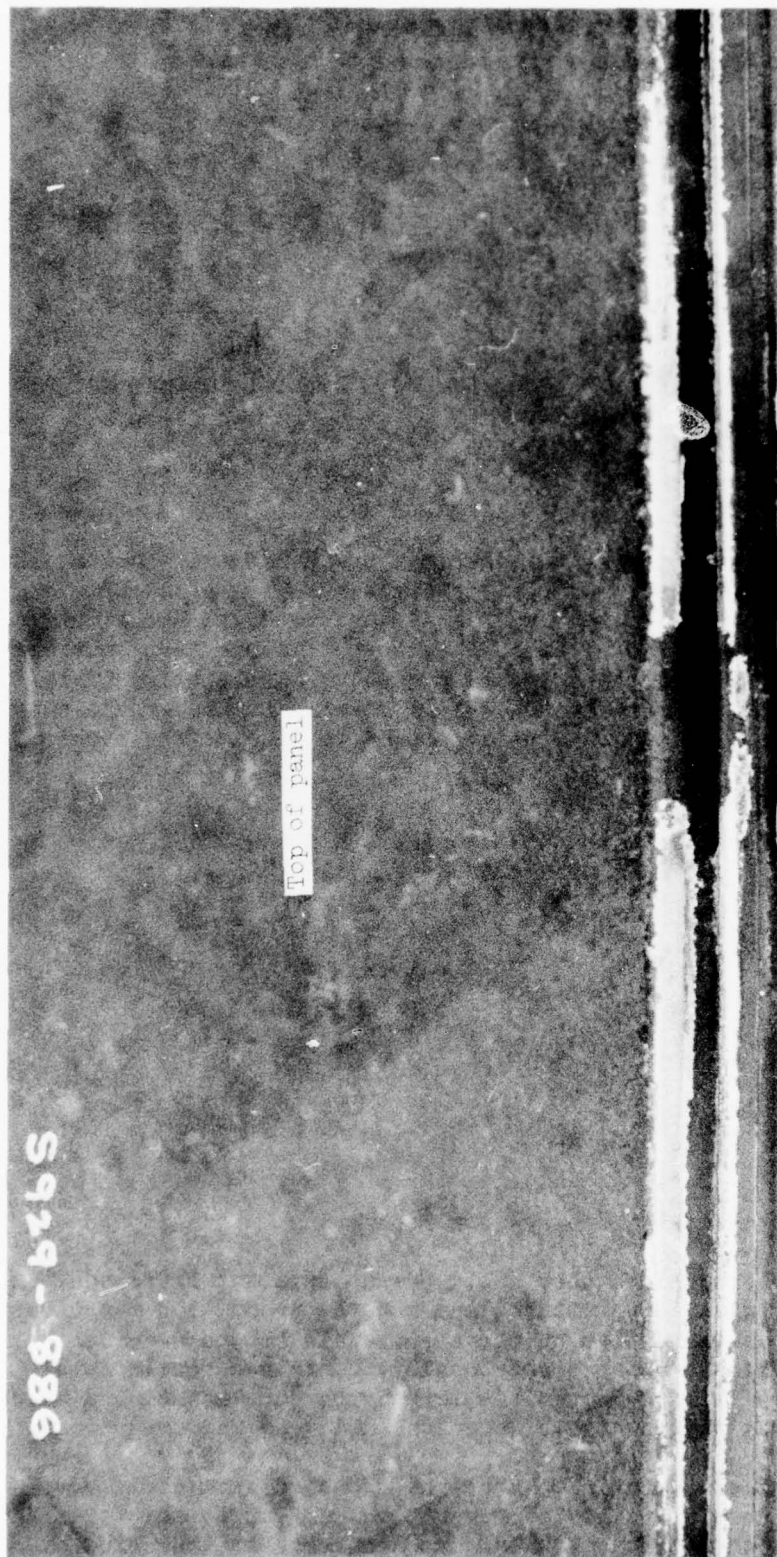
Wear and abrasion of male connector (at center of panel) after 240 coverages

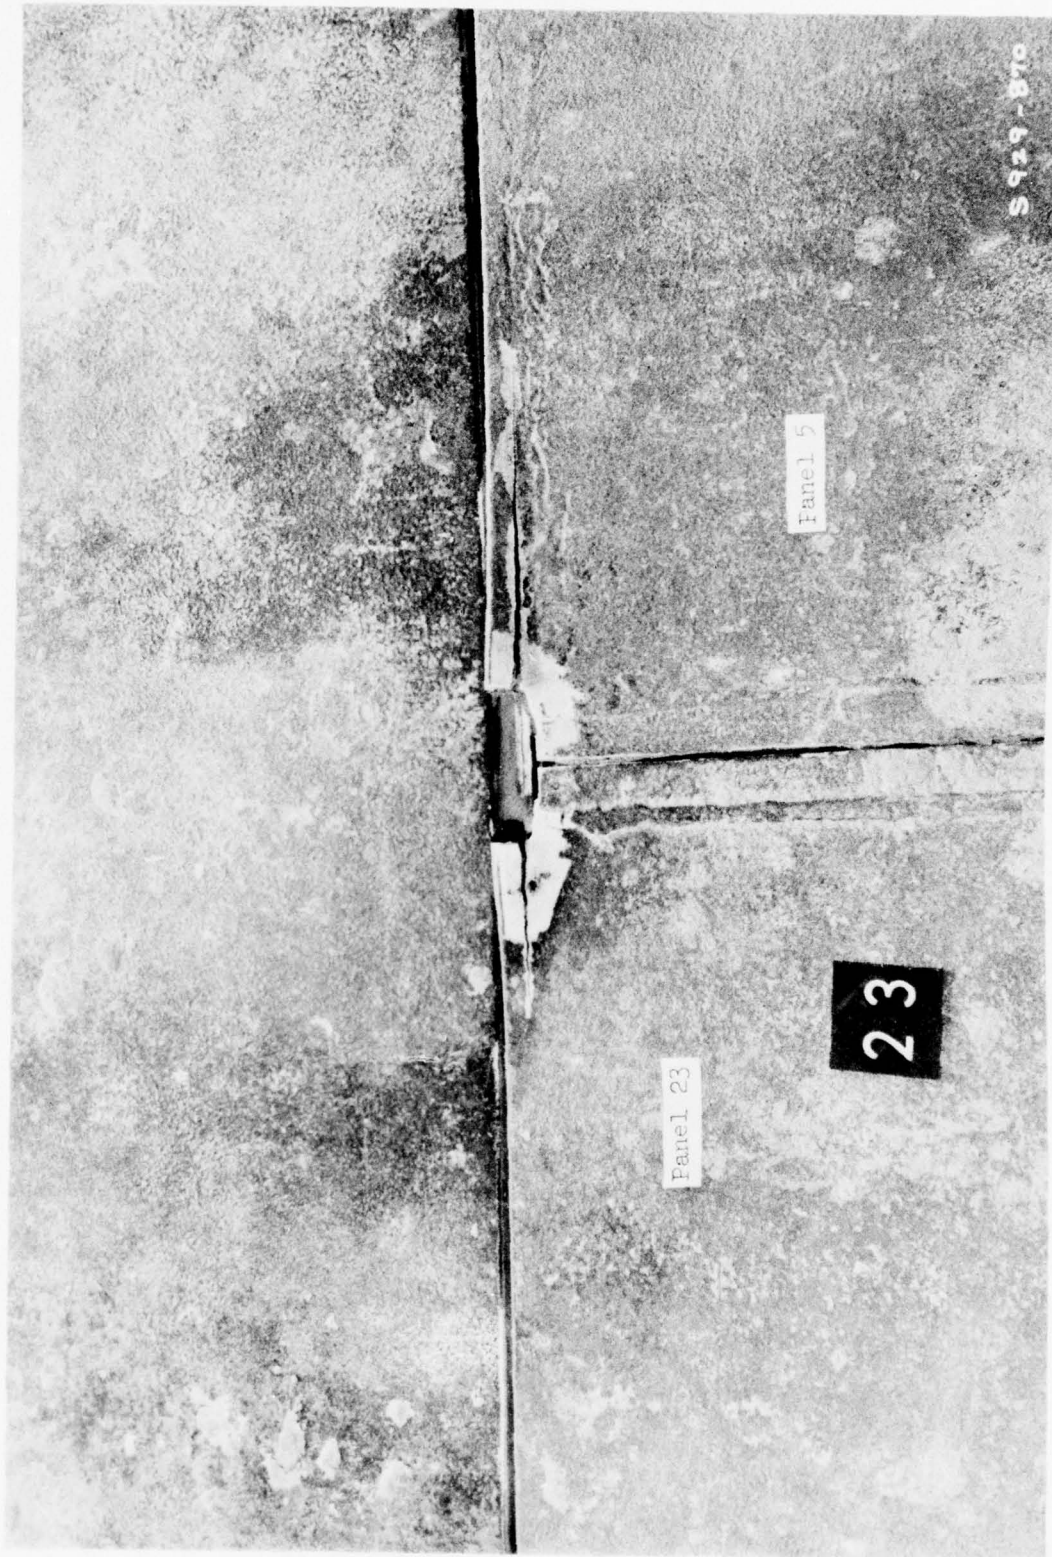
Panels 5 and 23 after 363 coverages of channelized traffic

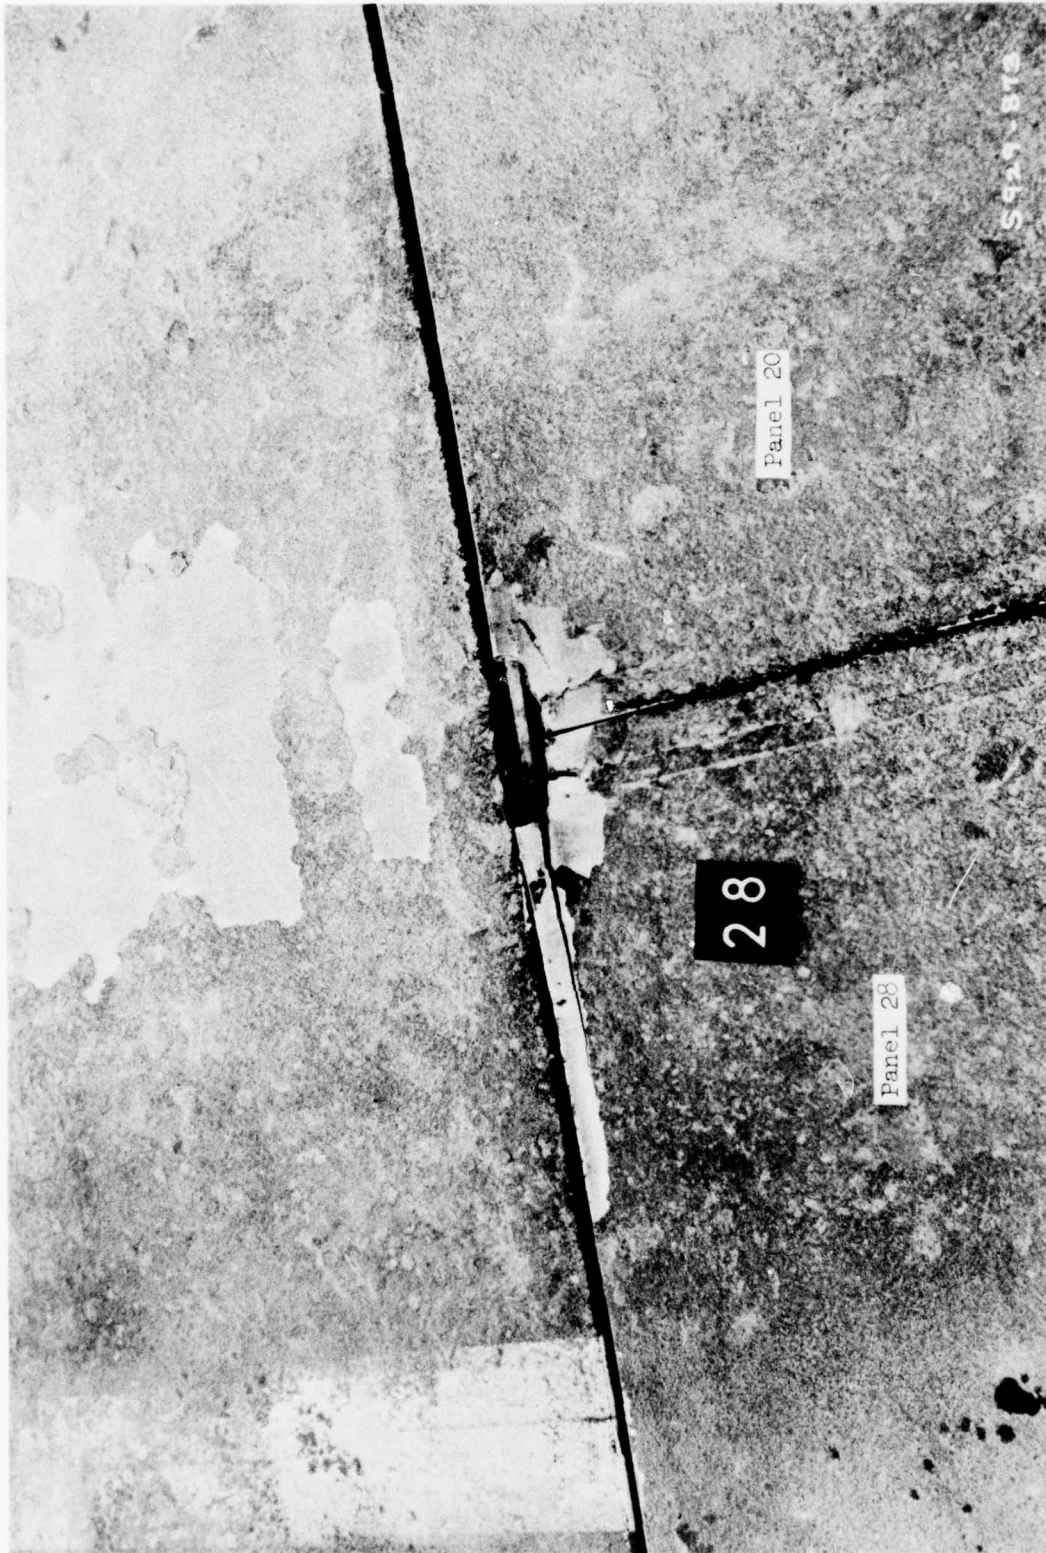
Panels 20 and 28 after 363 coverages of channelized traffic

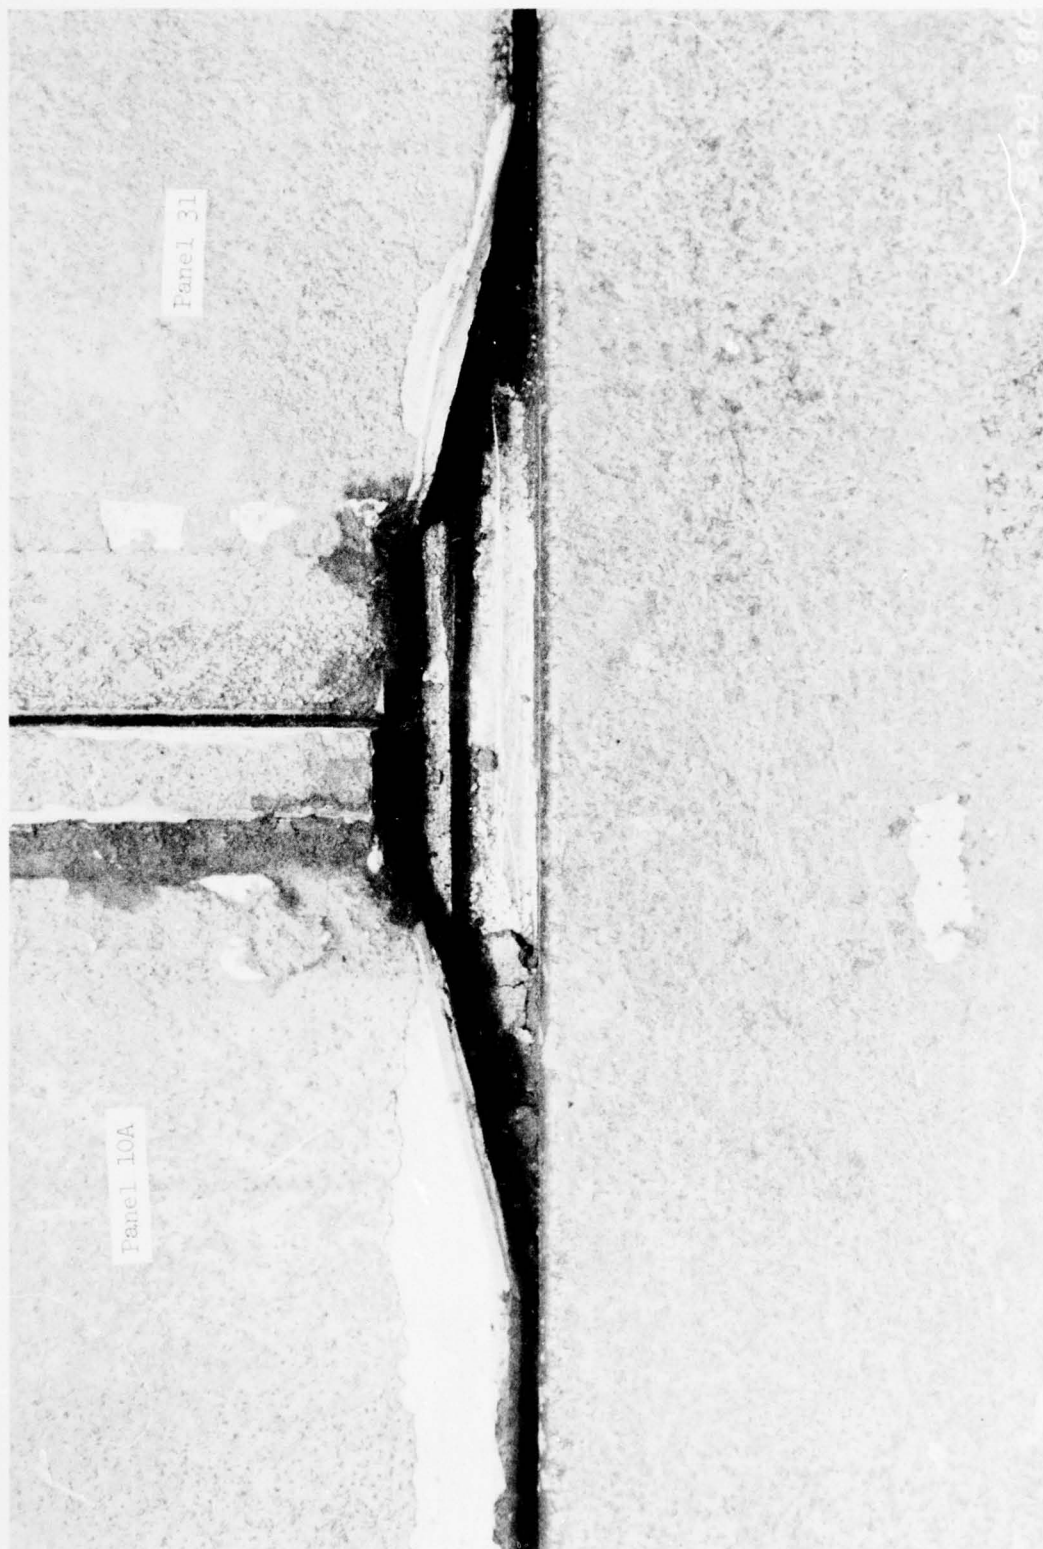
Panels 10A and 31 after 804 coverages of channelized traffic
